**Weston Solutions, Inc.**  
6779 Engle Road  
Building 2, Suite I  
Middleburg Heights, OH 44130  
Phone: (440) 202-2804

September 29, 2009

**Subject:** Asbestos Survey Overview  
**General Industries Asbestos Fund Lead Removal**  
**Elyria, Lorain County, Ohio**  
**Technical Direction Document No.: S05-0001-0909-010**  
**Contract No.: EP-S5-06-04**  
**Site Identification No.: B5QG**

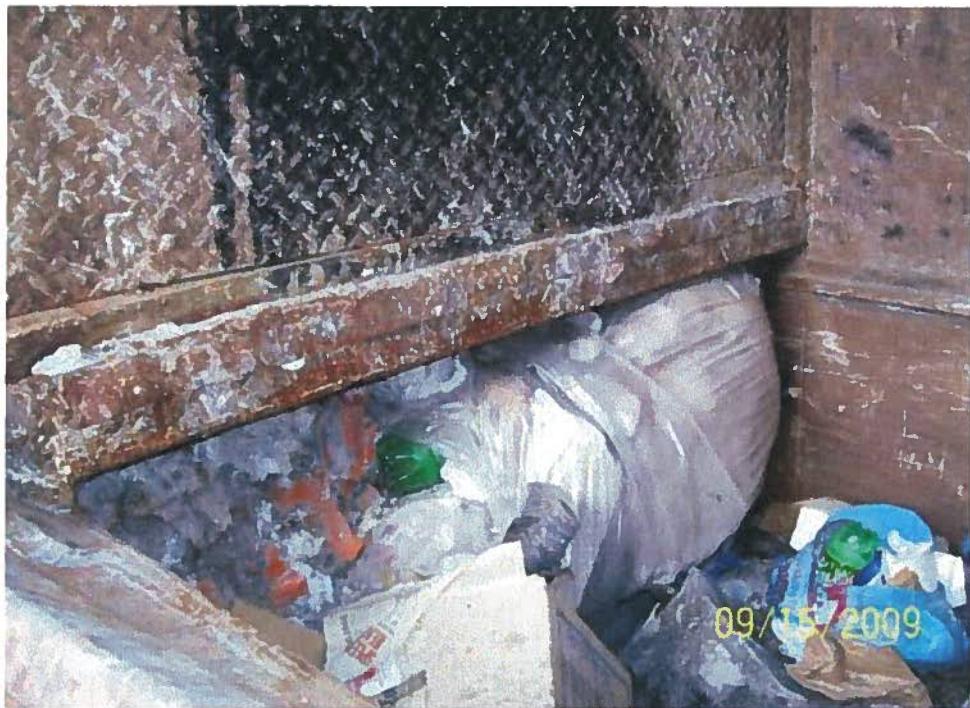
**Photograph No.:** 3

**Subject:** Asbestos Thermal System Insulation inside a dumpster on site (Building #24)

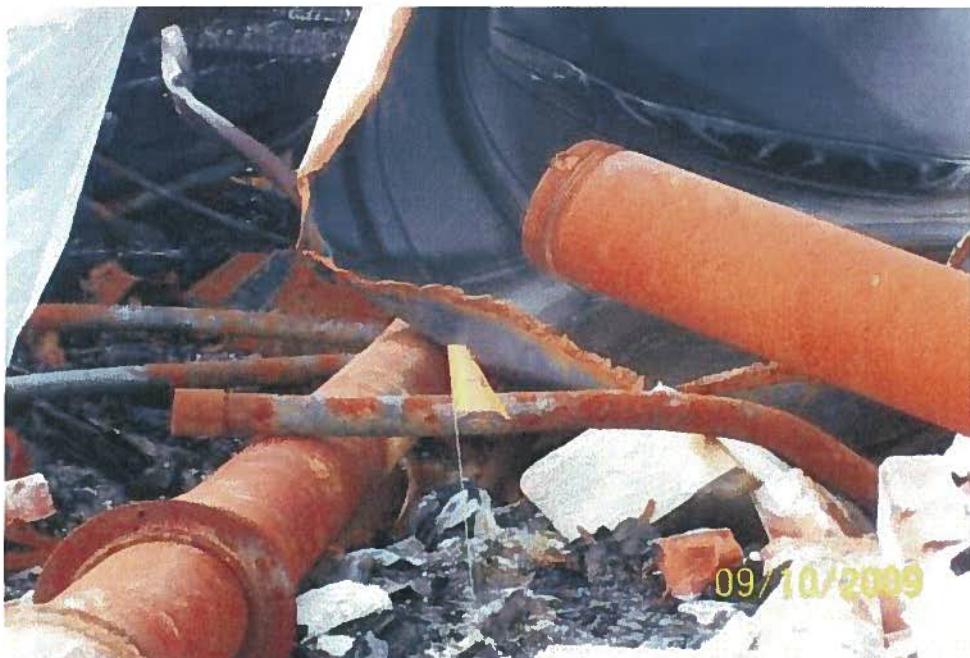
**Photograph No.:** 14

**Subject:** Sample 4-7-06, roofing material from Building #4-#7 (20% asbestos)

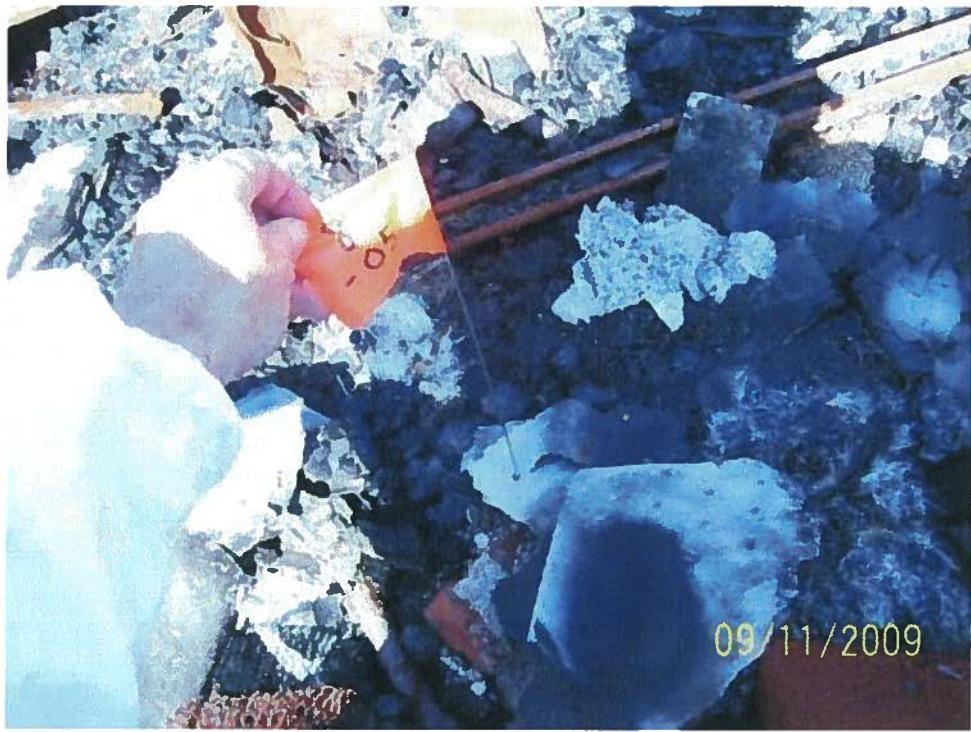
**Photograph No.:** 15

**Subject:** Sample 8-05, paper (suspect roofing) from Building #8 (60% asbestos)

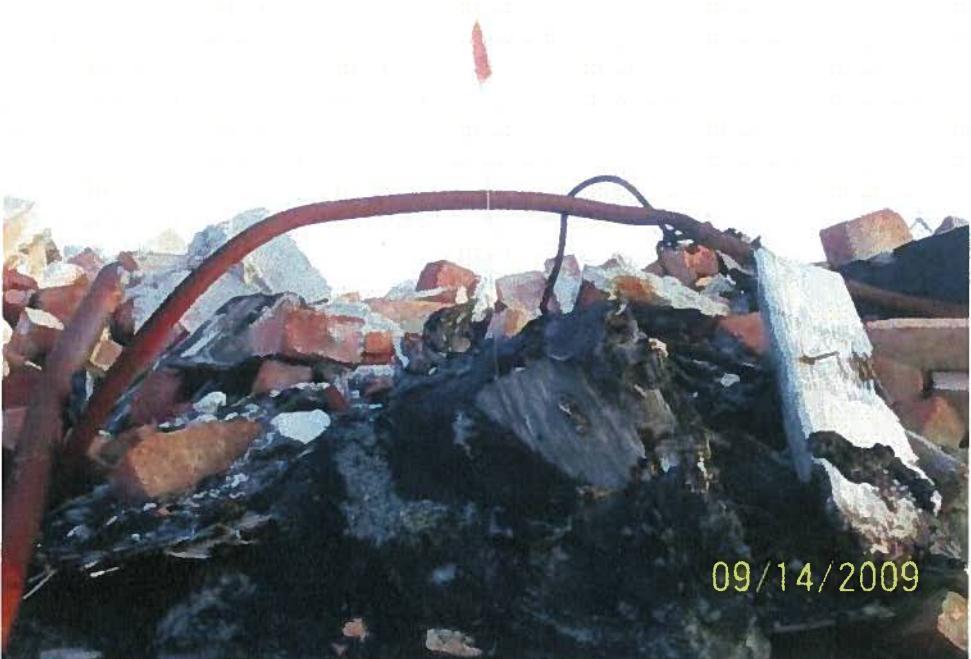
**Photograph No.:** 16

**Subject:** Sample 10-03A, roofing material from Building #10 (20% asbestos)

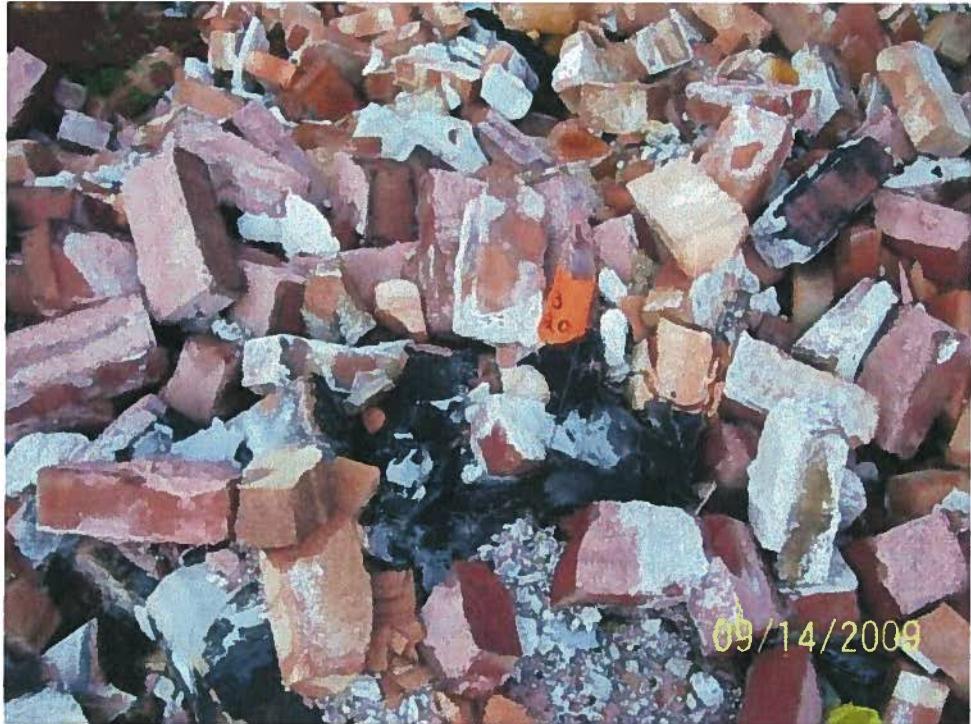
**Photograph No.:** 17

**Subject:** Sample 23-20, roofing material from Building #23 (20% asbestos)

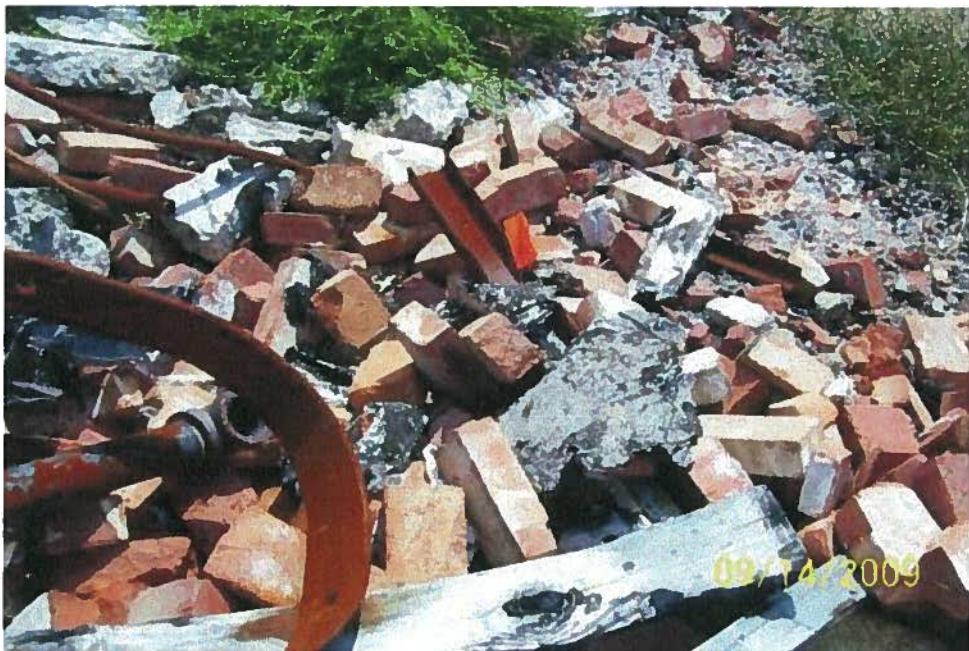
**Photograph No.:** 18

**Subject:** Sample 18-01, roofing material from Building #18 (60% asbestos)

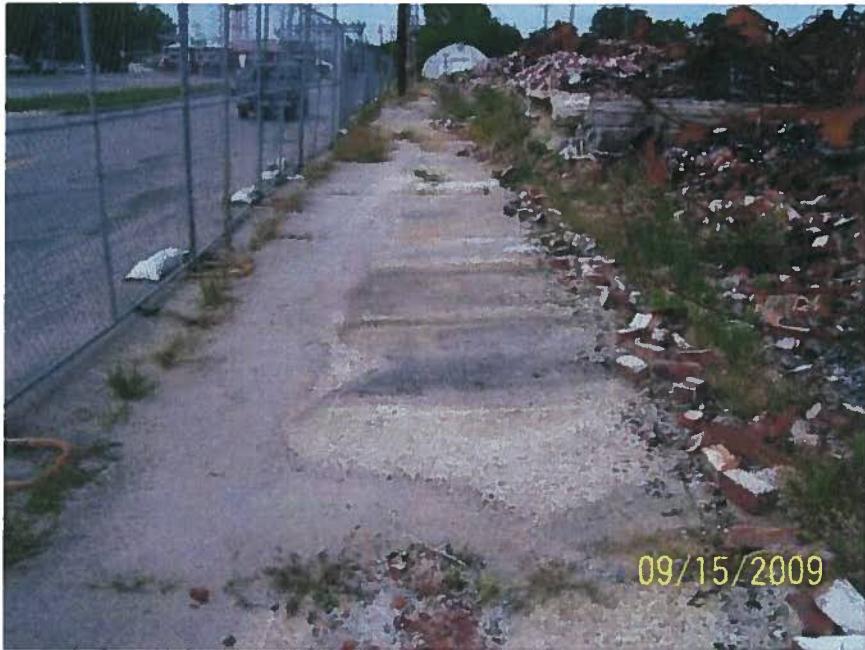
**Photograph No.:** 19

**Subject:** A general view of the southern perimeter of the Site and the sidewalk along Taylor Street (pulverized debris along the sidewalk and street)

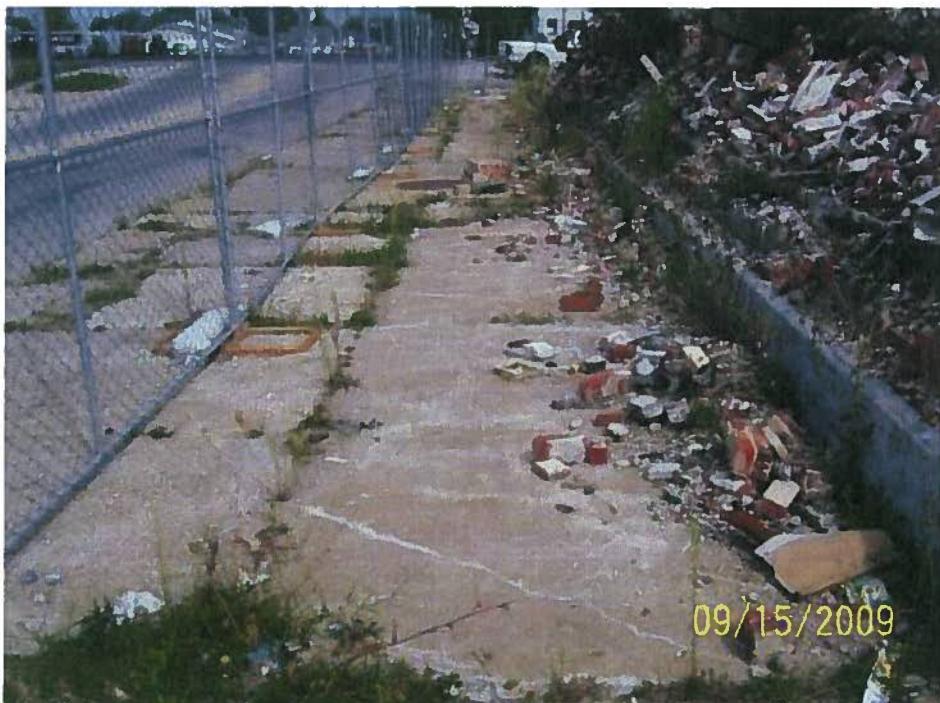
**Photograph No.:** 20

**Subject:** A general view of the western perimeter of the Site and the sidewalk along Olive Street (pulverized debris along the sidewalk and street)
